**Flood Control Project Maintenance
Levee Inspections**

Maintenance Issue Types Only, Levee Inspection Report By Mile - Spring 2019

Reclamation District No. 1001 Nicolaus

Waterway	Bank	Unit Miles	Inspection Start/End	Inspector
Unit No. 01 Yankee Slough	Right	4.12	03/12/2019 03/12/2019	Sterling York

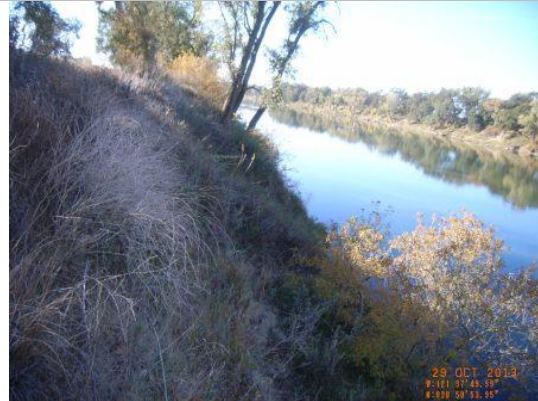
Photo 1 of 1 : SP_2019_RD1001_38_14_20190305_00004.jpg

Comment Code					
Inspector Comment					
2017 Site ID: FHR 5.0 L					
Status: Critical					
2017 Field Notes: Upgraded to critical, significant new erosion, entire bank slope is vertical with non cohesive soils.					
Site History: 2000 - Steep bank off berm with some slumps and fallen trees, continued erosion. 2002 - Site lengthened upstream and downstream due to vertical bank along most of the reach. 2010 - Site extended upstream. 2011 - Minimal new erosion. 2012 - Site extended on the upstream end, new tree pop-out, and bank erosion continues to worsen. 2013 - Minor new erosion at the toe and top of bank.					
Inspector notes: The erosion is not into the levee prism, Spring 2019.

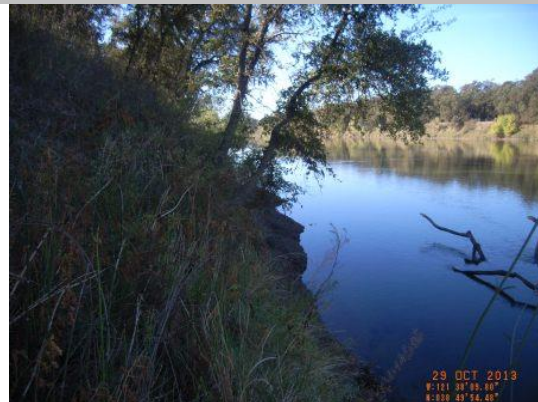
Photo 1 of 1 : SP_2019_RD1001_38_13_20190305_00003.jpg

LM Start	8.57	Rating **	A/W	Issue No.	13
LM End	8.97	Issue Type +	Ma	Location *	WS
Category	Supplemental			GPS Latitude/Longitude	
				Start	End
Item	2017 USACE Erosion Survey, DRAFT			38.836966 °	38.831498 °
				-121.634128 °	-121.636371 °
DWR ID	DWR_RD1001_04_f_2018_13				
Comment Code					
Inspector Comment					
2017 Site ID: FHR 3.8 L					
Status: Eroding					
2017 Field Notes: New erosion along lower slope					
Site History: 2006 - Sandy, silty bank with intermittent pockets of erosion. Rotational failure and tree pop outs are most of the problem. Some upper slope fluvial erosion. 2010 - Site extended upstream. The lower Feather may benefit from a regional repair. 2011 - Site combined with 3.6. Minimal new erosion. 2013 - New erosion observed at bank toe. Trees on site now have exposed roots.

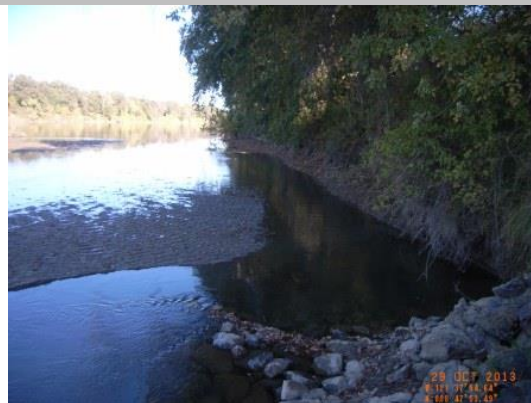
Photo 1 of 1 : SP_2019_RD1001_38_10_20190305_00002.jpg

LM Start	11.18	Rating **	M	Issue No.	10
LM End	11.37	Issue Type +	Ma	Location *	WS
Category	Supplemental			GPS Latitude/Longitude	
				Start	End
Item	2017 USACE Erosion Survey, DRAFT			38.800920 °	38.798165 °
				-121.633050 °	-121.631939 °
DWR ID	DWR_RD1001_04_f_2018_10				
Comment Code					
Inspector Comment					
2017 Site ID: FHR 1.0 L Status: Eroding 2017 Field Notes: Significant new erosion along lower bank. Site History: 2000 - Site is relatively stable except for some toe erosion at the upstream end, recommend monitoring the upstream end. 2004 - Some new block failures (10ft deep) at the toe of the upstream end. 2007 - Some minor new slumping at the waterline. 2013 - Minor new erosion along the bank toe.

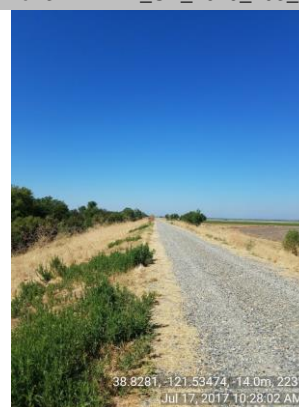
Photo 1 of 3 : LEVAL_SP_2019_493_1759.jpg

LM Start	5.05	Rating **	A/W	Issue No.	8	
LM End	5.06	Issue Type +	Ma	Location *		
Category	Supplemental			GPS Latitude/Longitude		
				Start		End
Item	2017 Storm Damage			38.828100 °	38.828188 °	
				-121.534740 °	-121.534625 °	
DWR ID	DWR_RD1001_05_f_2017_8					
Comment Code						
Inspector Comment						
Levee Evaluation Comments						
Description:						
Site ID No:493						
Site Designation:RD 1001-03						
Repair Type: Erosion						
Rating:Serious						
Field Date:7/17/2017						
Notes: Serious per senior review

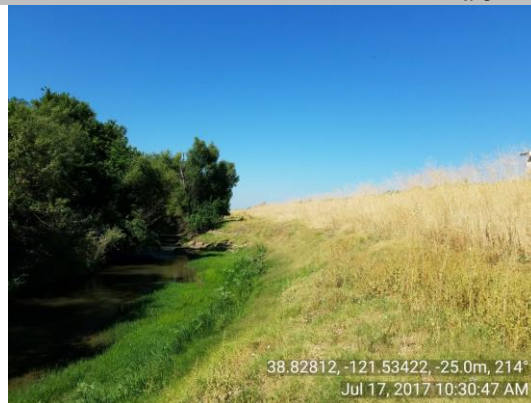
LM Start	5.05	Rating **	A/W	Issue No.	8 (cont)	
LM End	5.06	Issue Type +	Ma	Location *		
Category	Supplemental			GPS Latitude/Longitude		
				Start	End	
Item	2017 Storm Damage			38.828100°	38.828188°	
				-121.534740°	-121.534625°	
DWR ID	DWR_RD1001_05_f_2017_8					
Comment Code						
Inspector Comment						
Levee Evaluation Comments						
Description:						
Site ID No:493						
Site Designation:RD 1001-03						
Repair Type: Erosion						
Rating:Serious						
Field Date:7/17/2017						
Notes: Serious per senior review
